# 21 Chemical Tanker Explosion

Technical Investigations

- Investigation of the Cause of the Explosion
- Research to determine if the tank was correctly designed and built

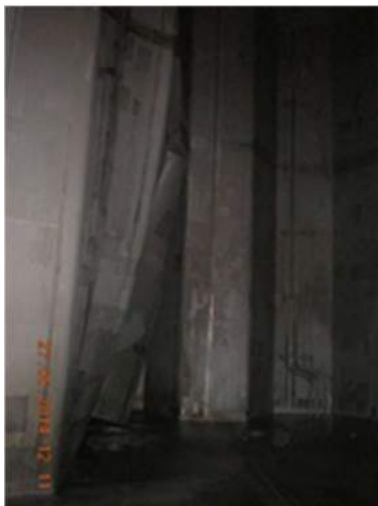
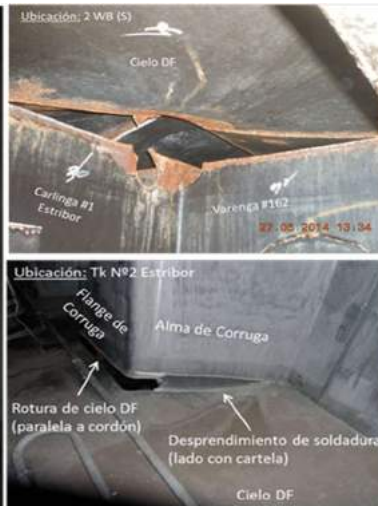
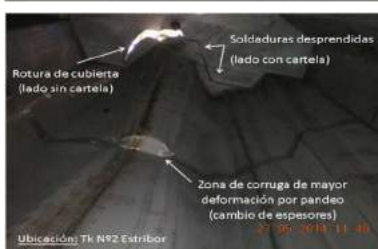
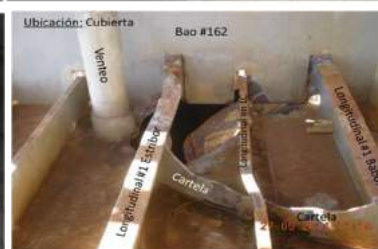
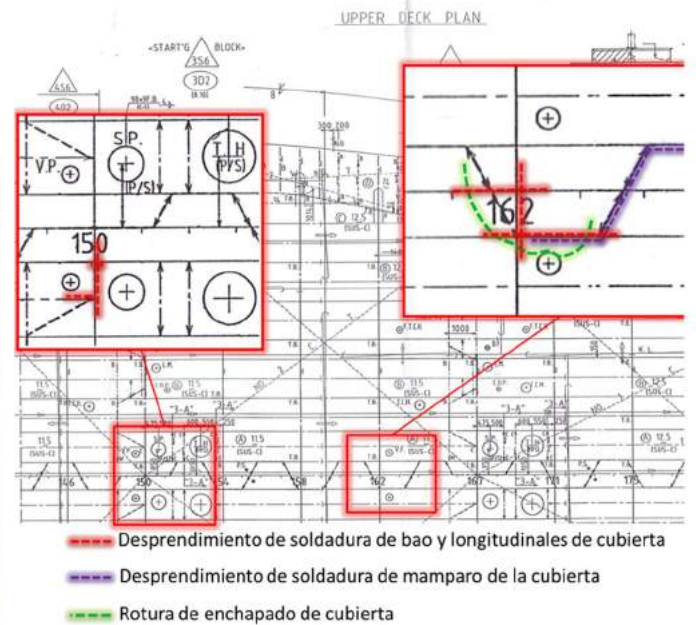
Extent of the damages.

The stainless-steel tanks bulkheads rip up in several places and the tanks in the area remained connected.

The nature and extent of the damages and other evidences found led to a failure hypothesis that was analyzed by means of a technical-scientific approach.

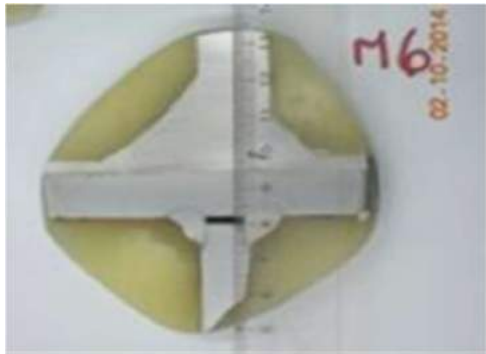
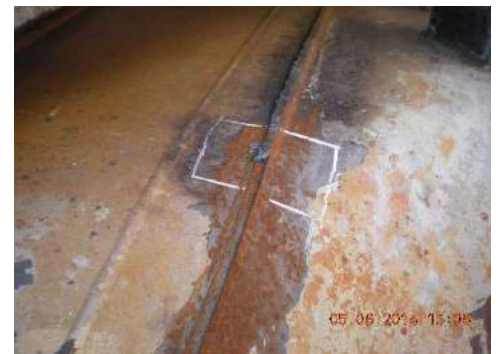
Laboratory, for macrographic, metallographic, electronic microscopy, microhardness, and spectrometric chemical analysis.

In the photos to the sides, a welding at the foot of the bulkhead was removed and investigated.

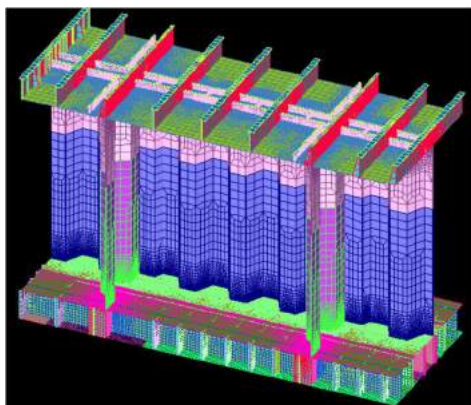
**FEM 1**

FEM1 analyzes the behavior of the structure as the relevant loads vary. FEM2 studies the stresses concentration due to the geometric discontinuity of the fillet weld connecting the bulkhead to the double bottom structure.

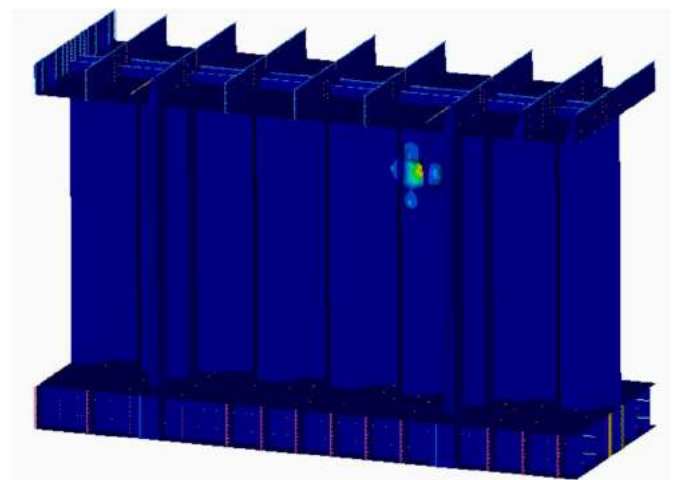
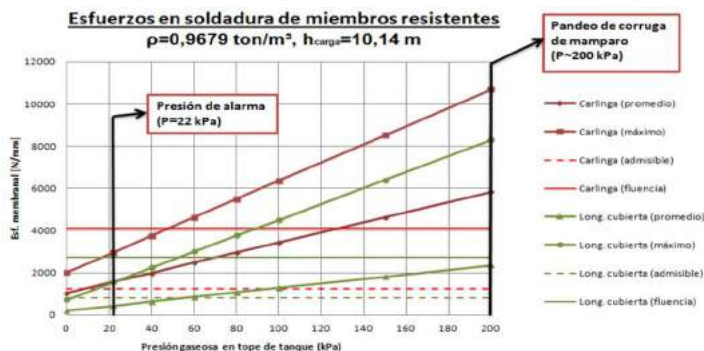
The bulkhead buckling modes were determined, and further analysed and compared.

Considering the welding sizes and material, the strength of the welding seams was evaluated.

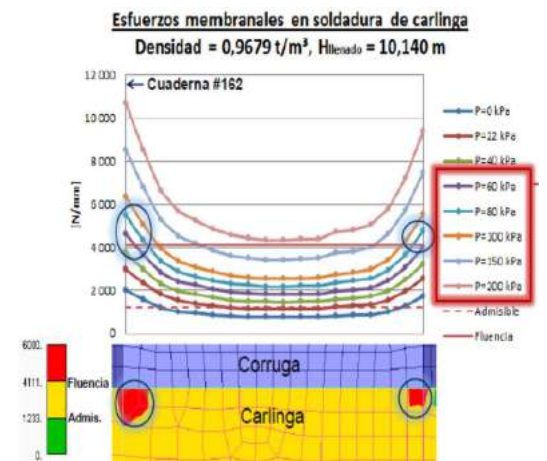
**The conclusion of this investigation was a realistic and solid probable failure mechanism.**

The start of yielding points for the relevant parts of the welding seams were determined for the different structural members and loading conditions.
