# 21 Chemical Tanker Explosion

Technical Investigations

- Investigation of the Cause of the Explosion
- Research to determine if the tank was correctly designed and built

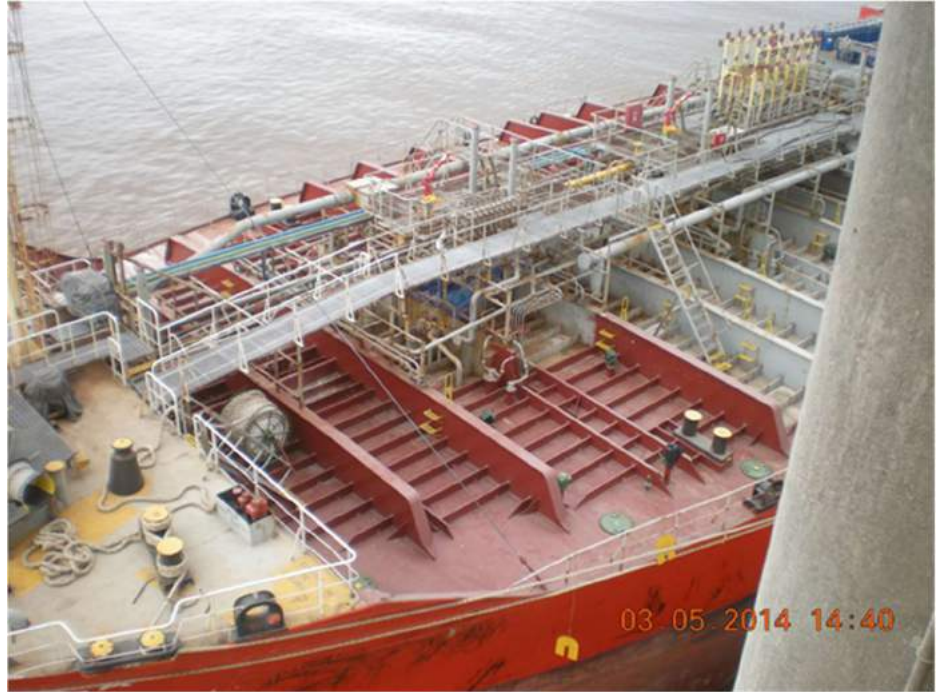
A chemical tanker completed loading Sodium Methylate/Methanol solution and the cargo line was being blown with nitrogen for final stripping; suddenly, a blast followed by a white cloud emerging from the bow area, evidenced the explosion.

The stainless-steel tanks bulkheads rip up in several places and the tanks in the area remained connected.
